Electronic Product Failure

A Case Study

Peter K. Rundle, Esq.
Rundle Law Corporation
California, USA

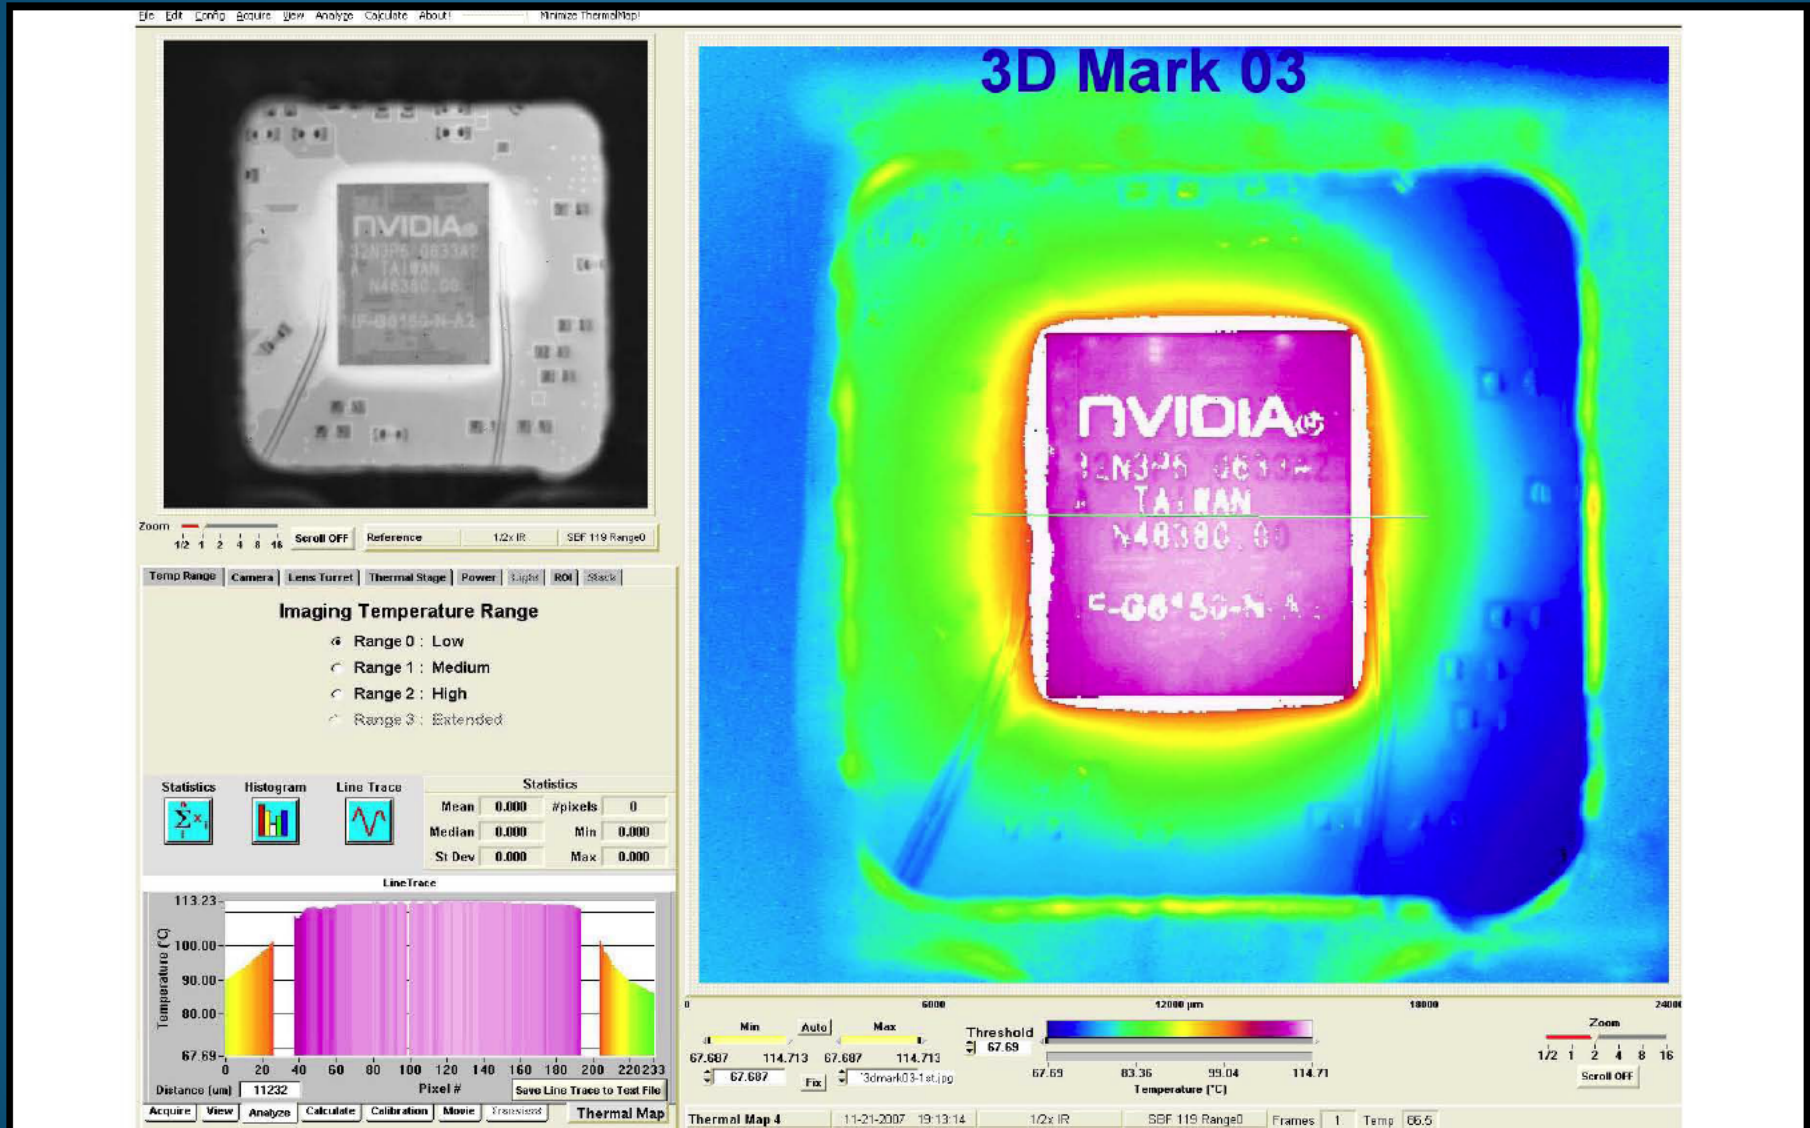
GPU Case Temperature

<u>GPU Operating Temp Rating</u>	<u>Actual</u>
90 deg. C Maximum	110+ deg. C
